PHOTOGRAPHIC SURVEY OF THE LDEF MISSION

NASA Special Publication 531

Robert L. O'Neal

National Aeronautics and
Space Administration

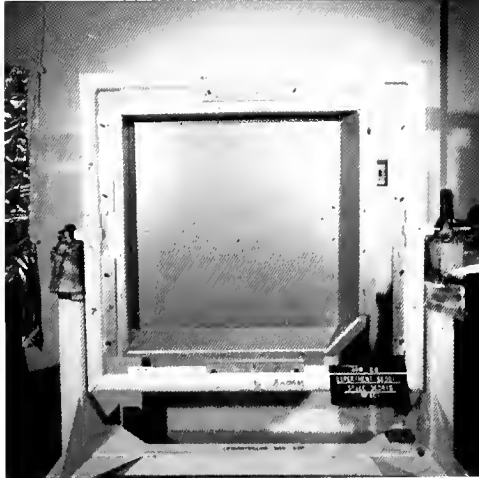
Figure 542 (Postflight). Irregular tan discolorations are visible on the lower experiment tray sidewall. The pink tint on the debris panel is a by-product of the chromic anodize coating process and is not attributed to contamination or exposure to the space environment. The light spots on the debris panel are the same abrasions that were observed in the in-flight photograph.

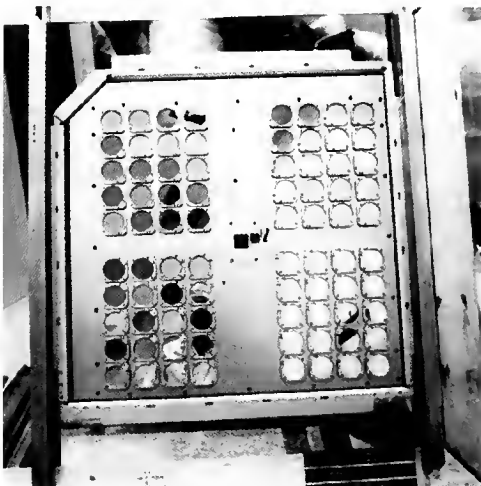
Figure 543 (Preflight). Experiment AO201 was an active experiment that exposed 80 detectors to the space environment. The experiment is described in the section "Preflight Figure 209." The colors on the detectors are the reflections of technicians and the surrounding clean room work area.

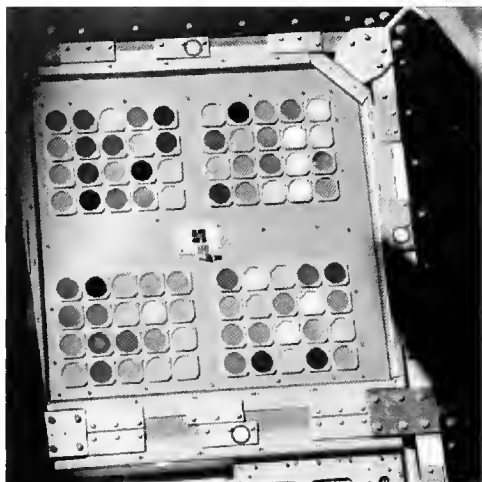
Figure 544 (In Flight). All experiment hardware seems to be in excellent condition and bond joints have maintained their integrity. The blue on the mirrorlike surface of the detectors is caused by reflections of the surroundings.

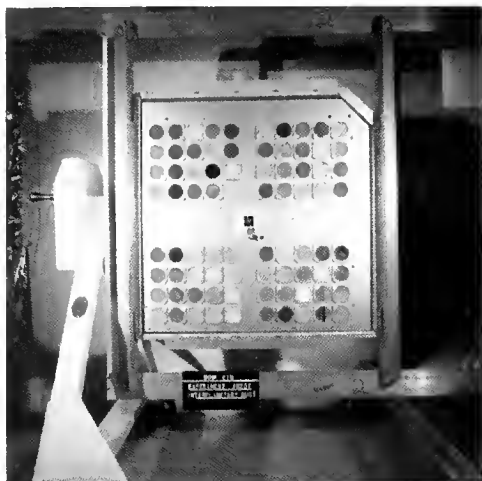
Figure 545 (Postflight). Experiment AO201 appears to have no visible degradation. The blue in the metallic surface of the detectors is caused by reflections of the surrounding area.

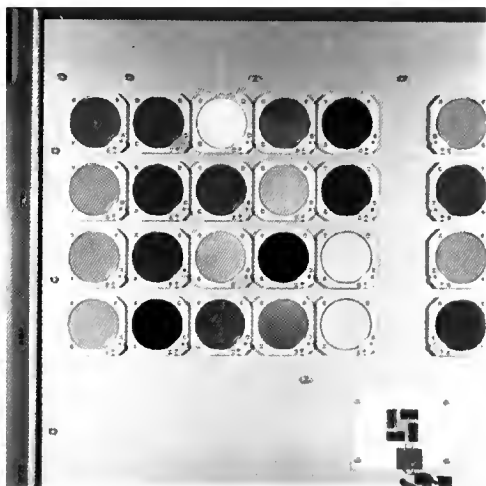
Figure 546
Photo No. KSC-390C-2068.09
Dup. Neg. No.: L91-11689
LISAR NO.: EL-1994-00468
Photo Credit: KSC
Photo Date: 3/19/90
Location: KSC SAEF II
Subject: Postflight Detail of Upper Left of Tray G10

Figure 546 (Postflight). This photograph is of the upper left one-fourth of the tray. The blue on the mirrorlike surface of the detectors is caused by reflections of the surroundings. Small impact craters are visible on some detectors. Surface scratches are also visible on the baseplate.

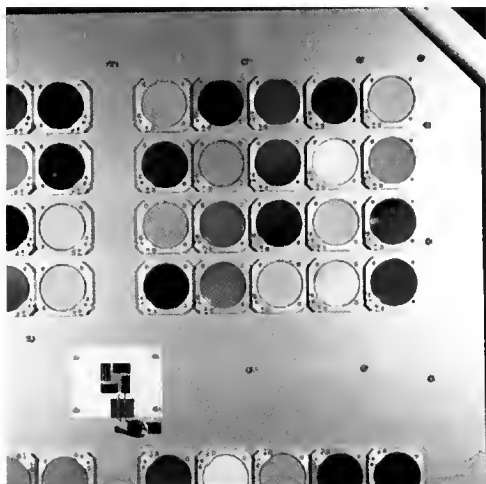
Figure 547
Photo No. KSC-390C-2068.10
Dup. Neg. No.: L91-11690
LISAR NO.: EL-1994-00469
Photo Credit: KSC
Photo Date: 3/19/90
Location: KSC SAEF II
Subject: Postflight Detail of Upper Right of
Tray G10

Figure 547 (Postflight). This photograph is of the upper right one-fourth of the tray. Small impact craters are visible on some detectors. The blue on the mirrorlike surface of the detectors is caused by reflections of the surroundings. Surface scratches are visible on the baseplate.

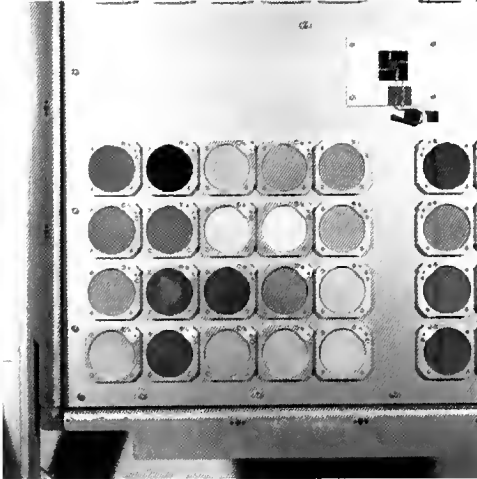
Figure 548 (Postflight). This photograph is of the lower left one-fourth of the tray. The blue on the mirrorlike surface of the detectors is caused by reflections of the surroundings. Small impact craters are visible on some detectors. Surface scratches are also visible on the baseplate. A pie-shaped discoloration is visible on the detector found second from the left and second from the bottom.

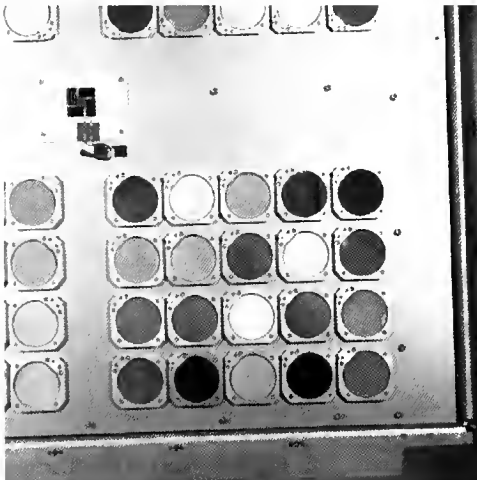
Figure 549 (Postflight). This photograph is of the lower right one-fourth of the tray. The blue on the mirrorlike surface of the detectors is caused by reflections of the surroundings. Small impact craters are visible on some detectors. Surface scratches are visible on the baseplate.

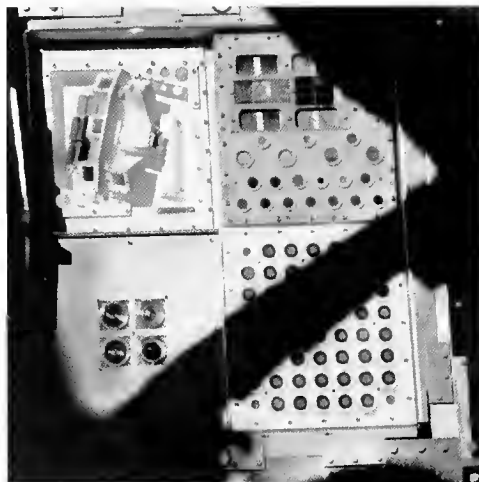
Figure 551
Photo No.: S32-76-054
Dup. Neg. No.: L90-10388
LISAR NO.: EL-1994-00668
Photo Credit: JSC
Photo Date: 1/12/90
Location: In Flight
Subject: In-Flight Survey of Tray G12

Figure 551 (In Flight). Shadows of the remote manipulator system cover a significant area of the picture. A light tan discoloration is visible on the baseplates and the mounting surfaces of the experiments. All experiment hardware appears intact.

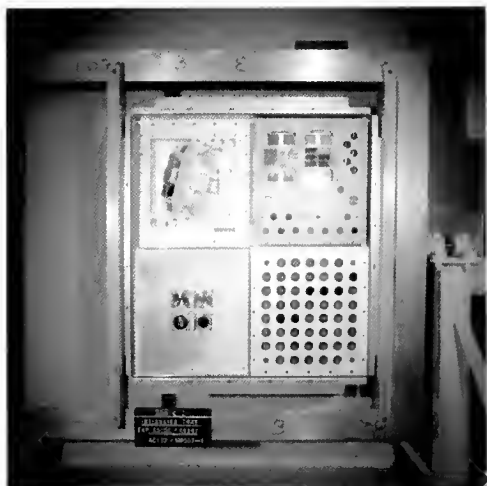
Figure 552
Photo No.: KSC-390C-1997.02
Dup. Neg. No.: L91-11718
LISAR NO.: EL-1994-00296
Photo Credit: KSC
Photo Date: 3/15/90
Location: KSC SAEF II
Subject: Postflight Survey of Tray G12

Figure 552 (Postflight). The experiment hardware appears intact. There are areas of discoloration on the baseplates and mounting structure of the experiments. The cover plate of experiment AO147 in the lower left, which was originally painted with Chemglaze II A276, now has a light tan discoloration over most of the surface area.

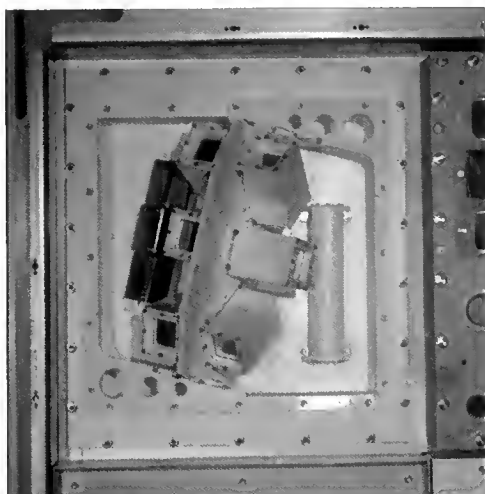
Figure 553
Photo No.: KSC-390C-1997.03
Dup. Neg. No.: L91-11719
LISAR NO.: EL-1994-00442
Photo Credit: KSC
Photo Date: 3/15/90
Location: KSC SAEF II
Subject: Postflight Detail of Upper Left of Tray G12

Figure 553 (Postflight). This photograph is of the upper left one-fourth of the tray. Experiment M0002-1 has a brown discoloration that is concentrated more heavily on areas that are away from the base. The hardware and sensors are intact.

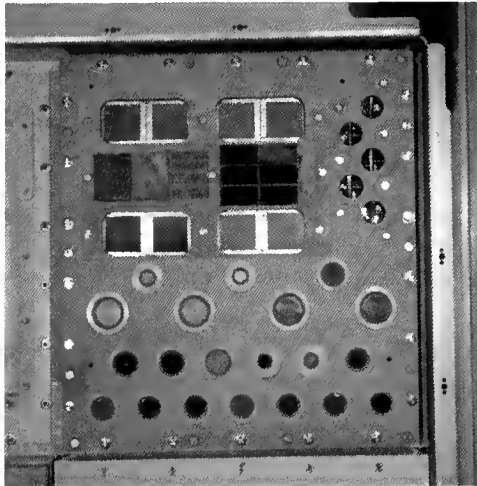
Figure 554 (Postflight). This photograph is of the upper right one-fourth of the tray. The faceplate of experiment AO056, which is painted with Chemglaze II A276 white paint, is much darker than in the preflight photograph. The discoloration is not uniform.

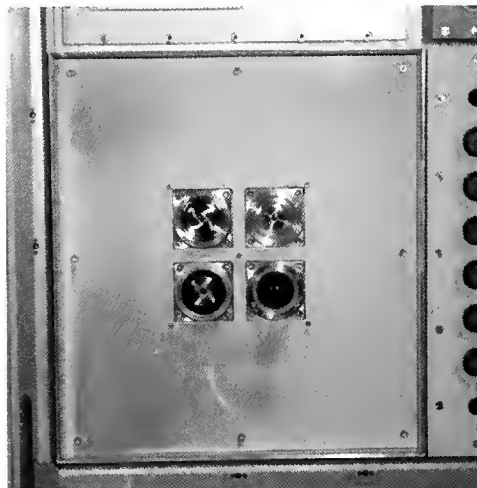
Figure 555 (Postflight). This photograph is of the lower left one-fourth of the tray. The faceplate of experiment AO147, which was painted with Chemglaze II A276, has areas of brown discoloration that are concentrated more on the left side. Note the discoloration flow pattern below the fasteners. The sensors are intact.

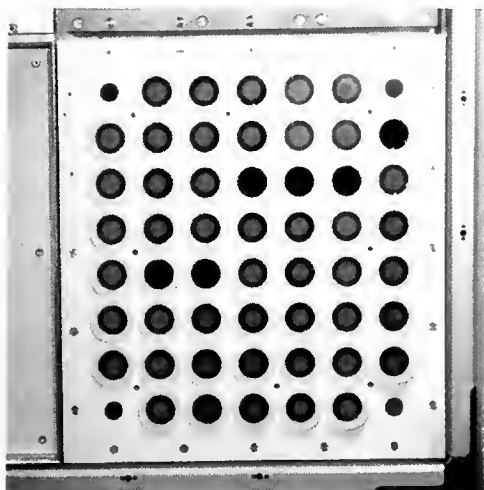
Figure 556
Photo No.: KSC-390C-1997.06
Dup. Neg. No.: L91-11722
LISAR NO.: EL-1994-00445
Photo Credit: KSC
Photo Date: 3/15/90
Location: KSC SAEF II
Subject: Postflight Detail of Lower Right of
Tray G12

Figure 556 (Postflight). This photograph is of the lower right one-fourth of the tray. The faceplate that was painted with Chemglaze II A276 white paint is slightly less white than in preflight. There are brown discoloration flow patterns below some of the sample holders. The test samples are intact.

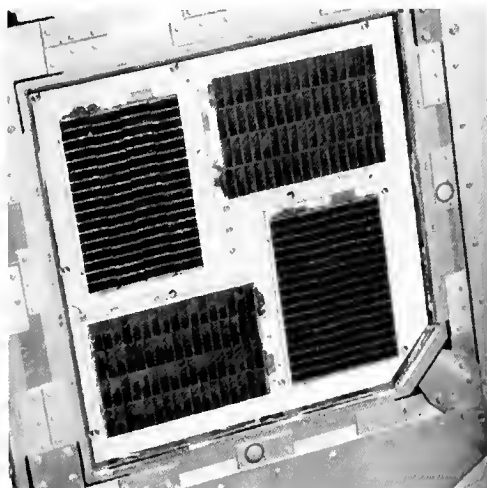
Figure 558
Photo No.: S32-75-036
Dup. Neg. No.: L90-10355
LISAR NO.: EL-1994-00085
Photo Credit: JSC
Photo Date: 1/12/90
Location: In Flight
Subject: In-Flight Survey of Tray H1

Figure 558 (In Flight). The white paint dots on the center clamp blocks of the right flange and lower flange of the experiment tray are discolored. The discoloration diminishes as the distance from the vent area of the thermal panels increases. The right and lower tray flanges near the vents also are discolored. Fingerprints are visible on the thermal panels in the vicinity of the panel mounting fasteners. The experiment hardware appears to be intact with no apparent changes other than stains along outer edges of the solar arrays.

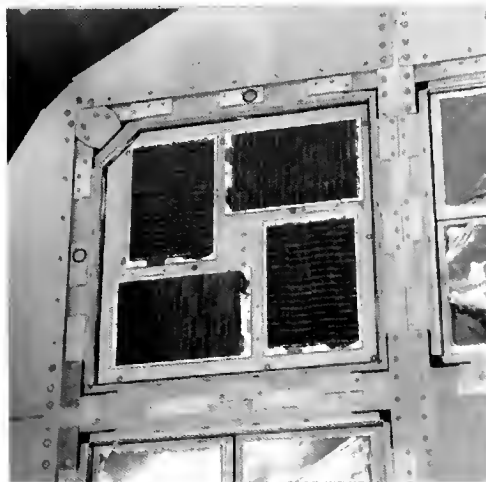
Figure 559
Photo No.: S32-S-282
Dup. Neg. No.: L92-21189
LISAR NO.: EL-1994-00071
Photo Credit: JSC
Photo Date: 1/22/90
Location: Shuttle Cargo Bay at Dryden
Subject: Postflight Survey of Tray H1

Figure 559 (Postflight). This photograph of experiment S1001 was taken from the cargo bay access hatch of the orbiter during postlanding operations at Dryden Flight Research Center. Note the discolorations on the structure of the LDEF, tray flanges, and tray clamp white dots. Note also the variation of discoloration with proximity to the thermal panel vents. Fingerprints are visible on the thermal panels in the vicinity of the panel mounting fasteners. The experiment hardware is intact with no apparent changes other than stains along outer edges of the solar arrays. The atomic oxygen samples in the upper left corner of the tray appear to be degraded. The Kapton tape is loose on the sample in the lower right corner of the tray and on the center sample on the upper tray flange. In other areas, the tape appears to be firmly adhered to the tray flanges.

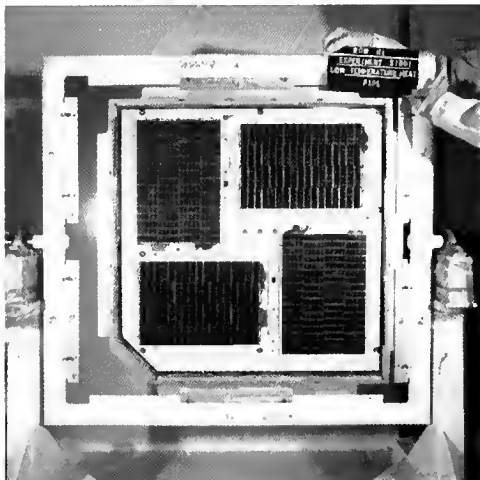
Figure 560
Photo No.: KSC-390C-2367.04
Dup. Neg. No.: L91-11748
LISAR NO.: EL-1994-00315
Photo Credit: KSC
Photo Date: 3/28/90
Location: KSC SAEF II
Subject: Postflight Survey of Tray H1

Figure 560 (Postflight). The experiment hardware is intact with no apparent changes other than stains along outer edges of the solar arrays. The light brown stains observed along the upper edges of the solar array mounting plates and around the outer edge of the baseplate in the in-flight photograph are not apparent in this postflight photograph.

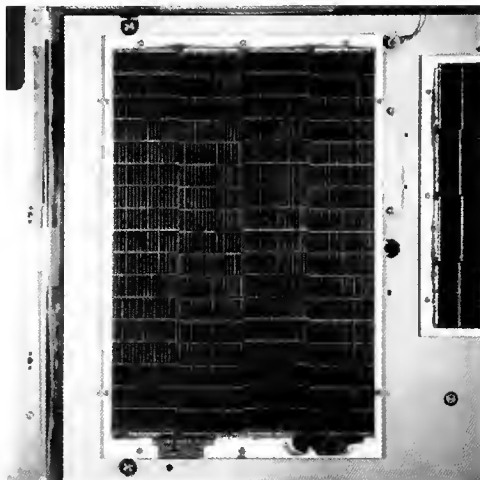
Figure 561
Photo No.: KSC-390C-2367.05
Dup. Neg. No.: L91-11749
LISAR NO.: EL-1994-00622
Photo Credit: KSC
Photo Date: 3/28/90
Location: KSC SAEF II
Subject: Postflight Detail of Upper Left of Tray H1

Figure 561 (Postflight). This photograph is of the upper left one-fourth of the tray. The solar cells appear intact. A few small impact craters on the array are visible. The atomic oxygen experiment samples that were attached to the tray flanges with Kapton tape are in place.

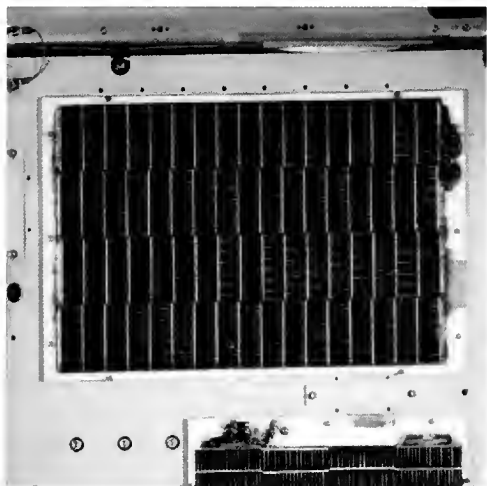
Figure 562
Photo No.: KSC-390C-2367.06
Dup. Neg. No.: L91-11750
LISAR NO.: EL-1994-00623
Photo Credit: KSC
Photo Date: 3/28/90
Location: KSC SAEF II
Subject: Postflight Detail of Upper Right of Tray H1

Figure 562 (Postflight). This photograph is of the upper right one-fourth of the tray. The solar cells appear intact. A few small impact craters on the array are visible. The Kapton tape that is holding atomic oxygen experiment samples to the tray flange is loose.

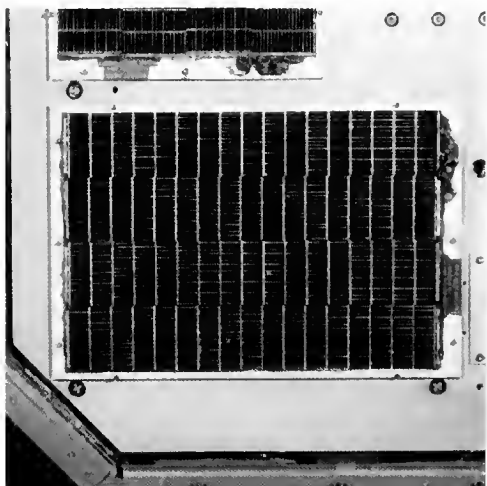
Figure 563
Photo No.: KSC-390C-2367.07
Dup. Neg. No.: L91-11751
LISAR NO.: EL-1994-00618
Photo Credit: KSC
Photo Date: 3/28/90
Location: KSC SAEF II
Subject: Postflight Detail of Lower Left of Tray H1

Figure 563 (Postflight). This photograph is of the lower left one-fourth of the tray. The solar cells appear intact. A few small impact craters on the array are visible. The atomic oxygen experiment samples on the left and in the center that were attached to the tray flanges with Kapton tape are damaged.

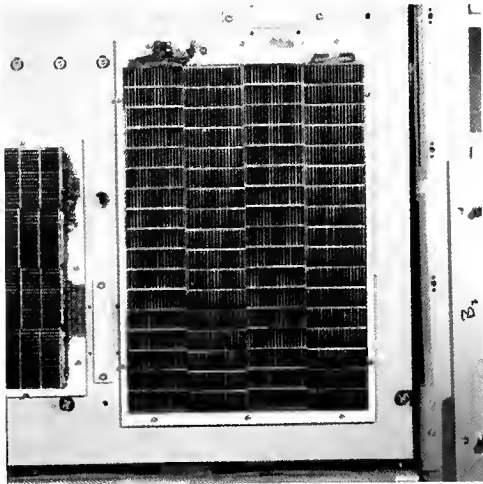
Figure 564 (Postflight). This photograph is of the lower right one-fourth of the tray. The solar cells appear intact. A few small impact craters on the array are visible. The atomic oxygen experiment samples attached to the tray flanges with Kapton tape are in place.

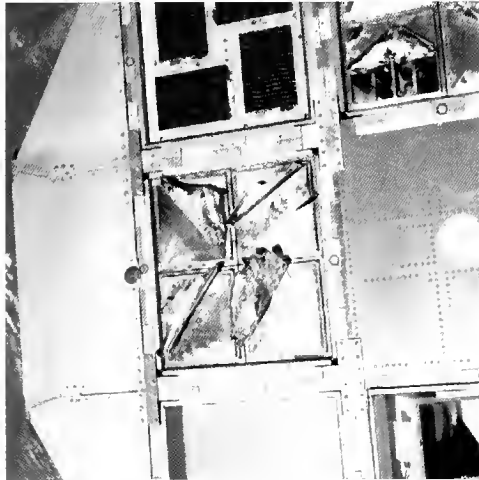
Figure 566
Photo No.: S32-75-043
Dup. Neg. No.: L90-10356
LISAR NO.: EL-1994-00670
Photo Credit: JSC
Photo Date: 1/12/90
Location: In Flight
Subject: In-Flight Survey of Tray H3

Figure 566 (In Flight). A light tan stain is visible on the end structure along the left edge of the tray flange. Lighter stains are also visible on the tray flange between the top and the center tray clamp blocks on the left side. The multilayer thermal insulation blanket has extensive damage. The tape joints have failed along two sides of each experiment module and have allowed the thermal blanket to curl back over itself. The gold-colored surfaces that have then been exposed are the top sheet of the Lexan detector stacks that are held securely in place by the Z shaped aluminum structure.

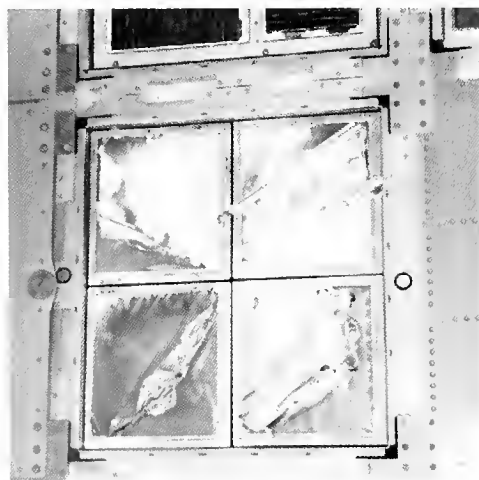
Figure 567
Photo No.: S32-S-278
Dup. Neg. No.: L92-21185
LISAR NO.: EL-1994-00070
Photo Credit: JSC
Photo Date: 1/22/90
Location: Shuttle Cargo Bay at Dryden
Subject: Postflight Survey of Tray H3

Figure 567 (Postflight). This photograph, which was taken from the cargo bay access hatch of the orbiter during postlanding operations at the Dryden Flight Research Center, shows extensive damage to the multilayer thermal insulation blanket. The tape joints appear to have failed along two sides of each experiment module and allowed the multilayer thermal insulation blanket to curl back over itself. The curls are now tighter than they were in flight. Note the discolorations on the structure of the LDEF, tray flanges, and tray clamp white dots and the variation of discoloration with proximity to the thermal panel vents. The paint on the top layer of the thermal blankets, which was originally white, now appears brown or light tan. The fragments of aluminum in the lower two quadrants appear to be from the delamination of the vapor-deposited aluminum from the thermal insulation blanket.

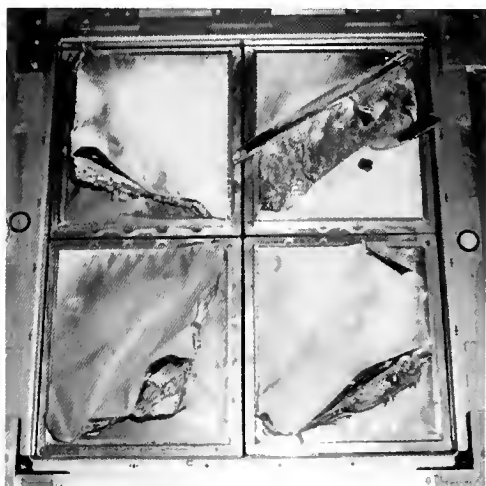
Figure 568
Photo No.: L90-01797
Dup. Neg. No.: None
LISAR NO.: EL-1994-00316
Photo Credit: LaRC
Photo Date: 2/6/90
Location: KSC SAEF II
Subject: Postflight Survey of Tray H3

Figure 568 (Postflight). This photograph shows the four experiment modules with the thermal blankets severely degraded. The paint on the top layer of the thermal blanket, previously white, is now a glossy tan or soft brown. The tape that was used to attach the thermal blanket to the module frames failed during flight. The tape failed in tension because of thermal shrinkage of the blankets, thus leaving tape on both the frame and the top layer of the thermal blanket. The material exposed underneath the thermal blanket is the top sheet of the detector stack. A Dacron mesh (bridal veil) separator is clearly visible in the upper right module. The coating of vapor-deposited aluminum has delaminated from the Mylar film and the Mylar film has eroded. The delaminated aluminum extends from the blanket in the lower right module. The loss of the Dacron mesh and some of the aluminum delamination is thought to have occurred prior to retrieval; however, a significant portion of the aluminum delamination from the Mylar is thought to have occurred postlanding because of the velocity and direction of air from the cargo bay purge system.

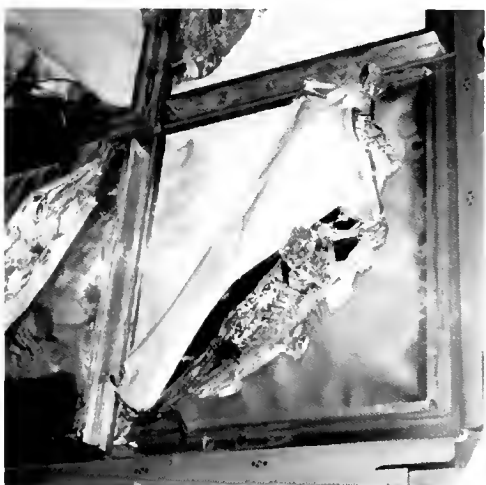
Figure 569
Photo No.: KSC-390C-828.01
Dup. Neg. No.: L91-15544
LISAR NO.: EL-1994-00068
Photo Credit: KSC
Photo Date: 2/6/90
Location: KSC SAEF II
Subject: Postflight Detail of Lower Right Module of
Tray H3

Figure 569 (Postflight). This photograph of the lower right module shows the discolorations and the extensive damage to the thermal blanket.

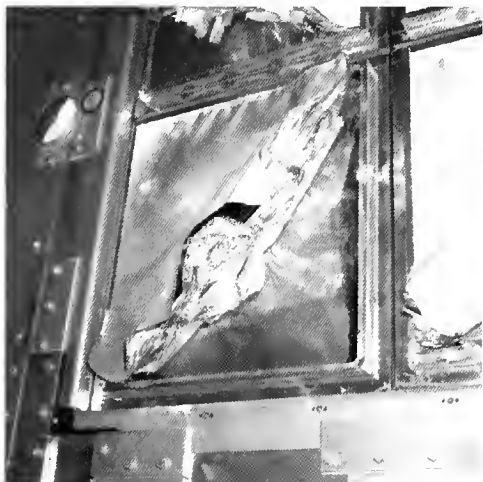
Figure 570 (Postflight). This photograph of the lower left module shows the discolorations and the extensive damage to the thermal blanket.

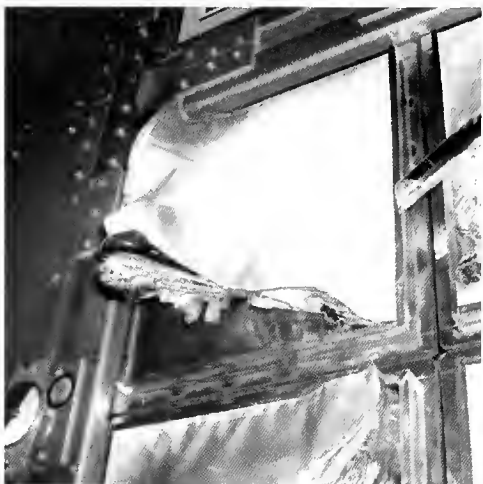
Figure 571 (Postflight). This photograph of the upper left module shows the discolorations and the extensive damage to the thermal blanket.

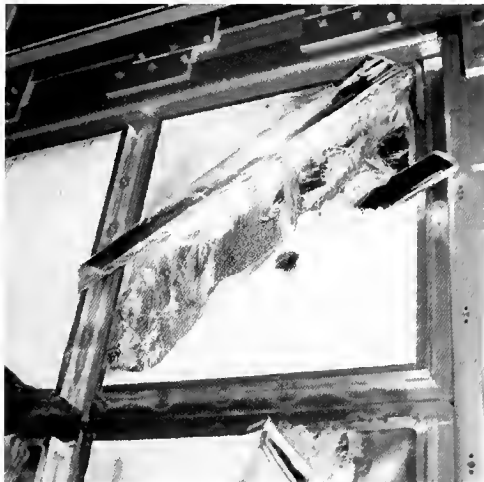
Figure 572
Photo No.: KSC-390C-828.04
Dup. Neg. No.: L91-15547
LISAR NO.: EL-1994-00176
Photo Credit: KSC
Photo Date: 2/6/90
Location: KSC SAEF II
Subject: Postflight Detail of Upper Right Module of
Tray H3

Figure 572 (Postflight). This photograph of the upper right module shows the discolorations and the extensive damage to the thermal blanket.

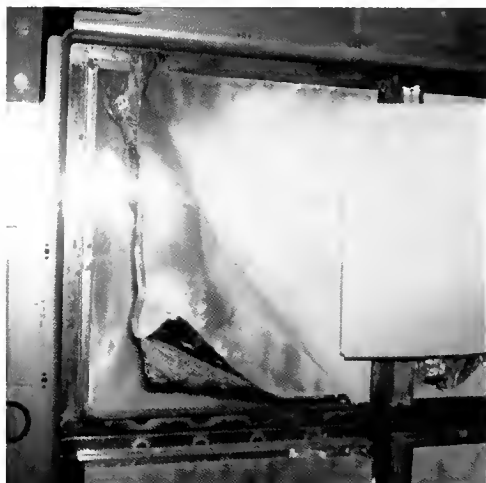
Figure 573
Photo No.: KSC-390C-829.04
Dup. Neg. No.: L91-15559
LISAR NO.: EL-1994-00285
Photo Credit: KSC
Photo Date: 2/6/90
Location: KSC SAEF II
Subject: Postflight Detail of Upper Left Module of
Tray H3

Figure 573 (Postflight). This photograph of the upper left module shows the discolorations and the extensive damage to the thermal blanket. A white reference card is also shown in the photograph.

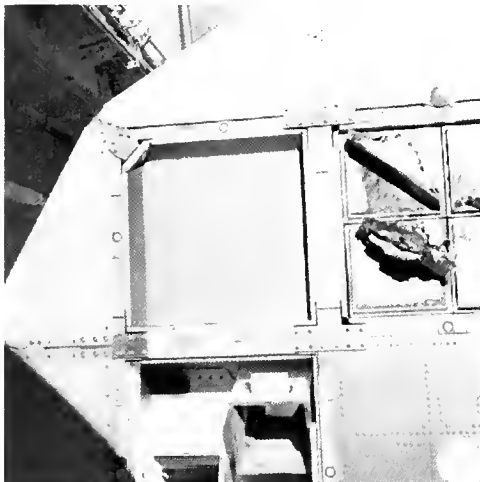
Figure 574 (In Flight). The paint dots on the experiment tray clamp blocks, which were originally white, show a tan stain that gets darker near the venting area of the end thermal panels. The stain also covers the top and left flanges of the experiment tray. To a lesser degree, the lower and right tray flanges are also covered with the stain. The vertical lines and the pinkish color of the debris panel are chromic anodize coating by-products and are not attributed to contamination or exposure to the space environment.

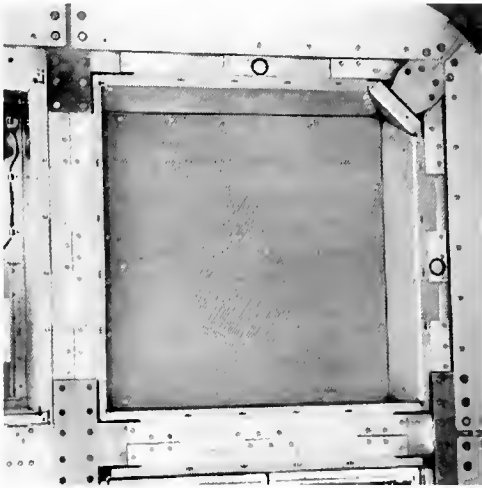
Figure 575 (Postflight). This photograph was taken from the cargo bay access hatch of the orbiter during postlanding operations at the Dryden Flight Research Center. Note the discolorations on the structure of the LDEF, tray flanges, and tray clamp white dots and the variation with proximity to the thermal panel vents. The discolorations on the tray sidewalls appear to be fingerprints enhanced by the brown stain. Light discolorations are located near the lower side of the debris panel. The horizontal lines and the pinkish tint of the debris panel are chromic anodize coating by-products and are not attributed to contamination or exposure to the space environment. Darker discolorations on the debris panel, similar to water marks, are apparent in the photograph.

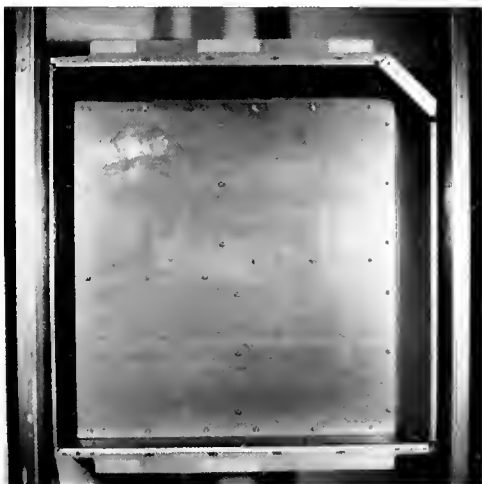
Figure 576 (Postflight). A brown discoloration is visible on the lower tray flange and a lighter discoloration is visible on the upper tray flange that is not covered by the experiment tray clamp blocks. Irregular tan discolorations are also visible on the experiment tray lower sidewall with a darker stain in the left tray corners.

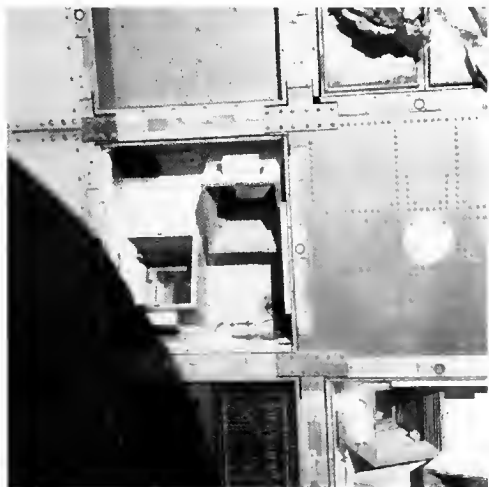
Figure 578
Photo No.: S32-75-063
Dup. Neg. No.: L90-10369
LISAR NO.: EL-1994-00674
Photo Credit: JSC
Photo Date: 1/12/90
Location: In Flight
Subject: In-Flight Survey of Tray H6

Figure 578 (In Flight). A shadow of the shuttle obscures part of the tray. A very light contamination stain is present on the experiment tray flanges and on most of the visible structure. An exception is a much darker stain on the structure adjacent to thermal panels that provided venting for the interior of the LDEF. The white thermal control paint now varies from off-white to a dark brown. Localized dark brown areas in the tray are visible. A beryllium copper collector foil is clearly visible in the lower left canister housing as are the baffles. Light from the fine wire mesh grid is reflected near the top of the canister housing. Because of an experiment system malfunction, the canister collector foils that are visible were exposed for the total mission.

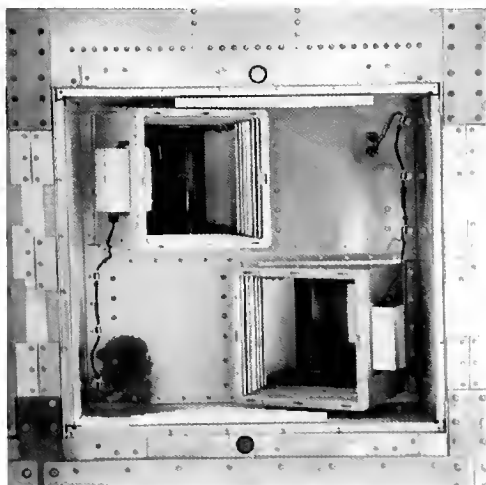
Figure 579
Photo No.: S32(S)-290
Dup. Neg. No.: L92-21197
LISAR NO.: EL-1994-00076
Photo Credit: JSC
Photo Date: 1/22/90
Location: Shuttle Cargo Bay at Dryden
Subject: Postflight Survey of Tray H6

Figure 579 (Postflight). This photograph was taken from the cargo bay access hatch of the orbiter during postlanding operations at the Dryden Flight Research Center. Note the discolorations on the structure of the LDEF, tray flanges, and tray clamp white dots and the variation of discoloration with proximity to the thermal panel vents. The darker appearance of the tray interior is probably due to lighting. A beryllium copper collector foil is clearly visible within the canister housings as are the baffles. Reflected light from the fine wire mesh grid is visible near the top of the canister housing.

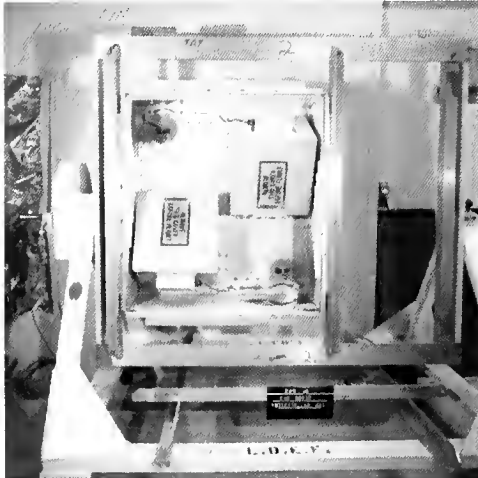
Figure 580
Photo No.: KSC-390C-1641.03
Dup. Neg. No.: L91-11828
LISAR NO.: EL-1994-00215
Photo Credit: KSC
Photo Date: 3/6/90
Location: KSC SAEF II
Subject: Postflight Survey of Tray H6

Figure 580 (Postflight). The brown stains are still very prominent and appear to be the same as in the in-flight photograph. The covers have been installed on the canister housings to protect the space-exposed hardware. The contamination stain shows an outline of tray clamp-block locations on the experiment tray flanges.

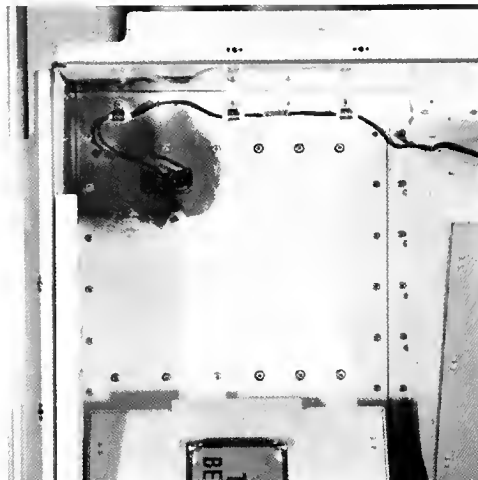
Figure 581
Photo No.: KSC-390C-1641.04
Dup. Neg. No.: L91-11829
LISAR NO.: EL-1994-00051
Photo Credit: KSC
Photo Date: 3/6/90
Location: KSC SAEF II
Subject: Postflight Detail of Upper Left of Tray H6

Figure 581 (Postflight). This photograph is of the upper left one-fourth of the tray. Note the extreme dark brown discoloration around the grid voltage plug in the corner of the tray.

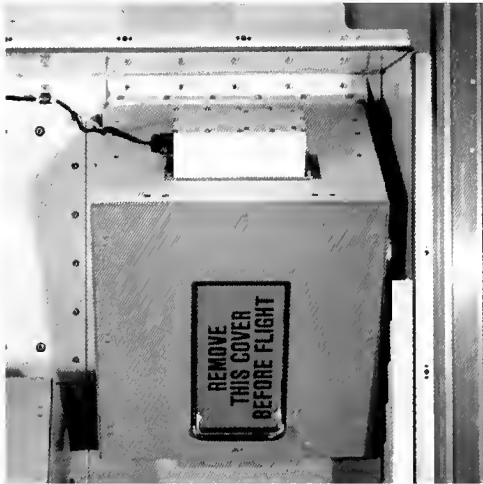
Figure 582
Photo No.: KSC-390C-1641.05
Dup. Neg. No.: L91-11830
LISAR NO.: EL-1994-00052
Photo Credit: KSC
Photo Date: 3/6/90
Location: KSC SAEF II
Subject: Postflight Detail of Upper Right of Tray H6

Figure 582 (Postflight). This photograph is of the upper right one-fourth of the tray. Some dark contamination is visible below the canister. Some shadows are caused by photographic lighting. The cover has been installed on the canister housing to protect the space-exposed hardware.

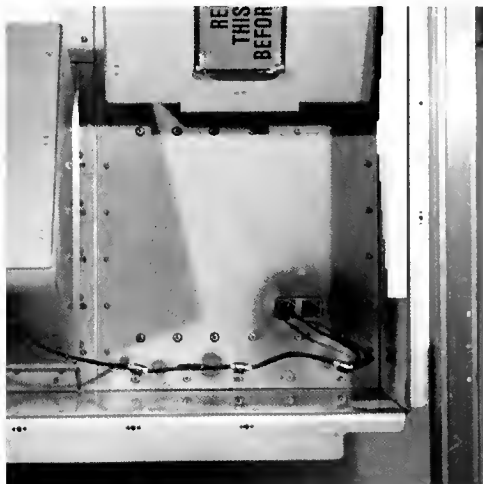
Figure 583
Photo No.: KSC-390C-1641.06
Dup. Neg. No.: L91-11831
LISAR NO.: EL-1994-00053
Photo Credit: KSC
Photo Date: 3/6/90
Location: KSC SAEF II
Subject: Postflight Detail of Lower Right of
Tray H6

Figure 583 (Postflight). This photograph is of the lower right one-fourth of the tray. Note the extreme brown discoloration around the grid voltage leads and plug. The cover has been installed on the canister housing to protect the space-exposed hardware.

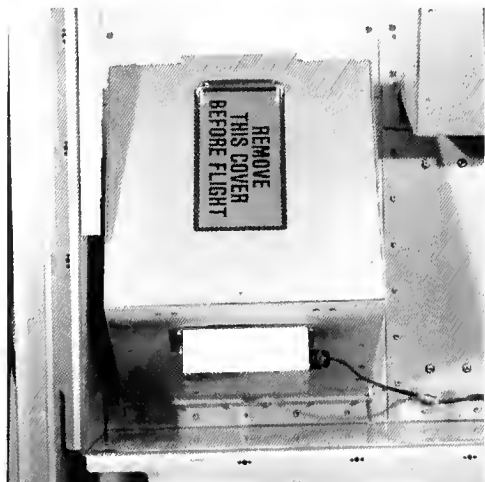
Figure 584 (Postflight). This photograph is of the lower left one-fourth of the tray. Note the extreme brown discoloration on tray and canister sides. The cover has been installed on the canister housing to protect the space-exposed hardware.

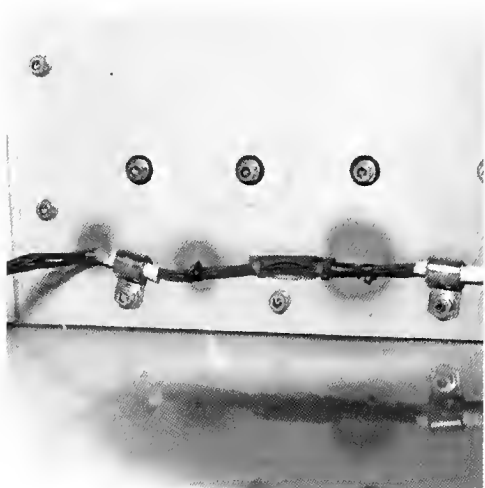
Figure 585 (Postflight). This close-up photograph is of the lower right corner of the tray. Note the localized extreme brown discoloration around the electrical cable wraps. There is a reflection of the cable in the tray sidewall.

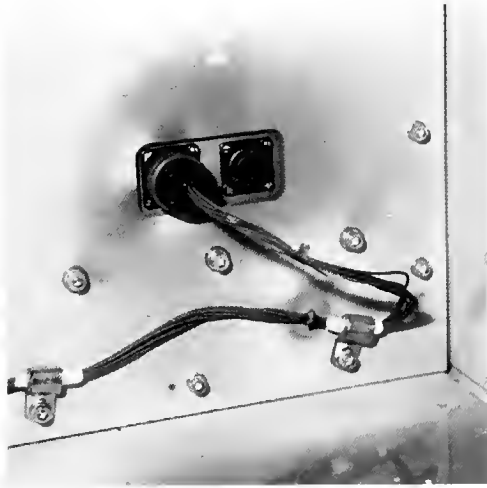
Figure 586 (Postflight). This close-up photograph is of the lower right corner of the tray. Note the brown discoloration around the grid voltage plug and around the cable wraps.

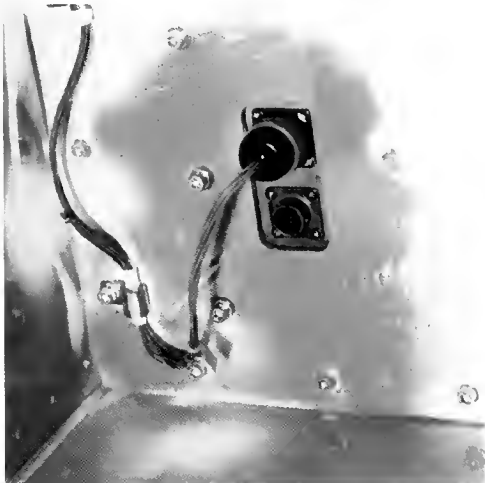
Figure 587 (Postflight). This close-up photograph is of the upper left corner of the tray. Note the extreme brown discoloration patterns. There is a distinct pattern of the grid voltage cable on the tray side wall.

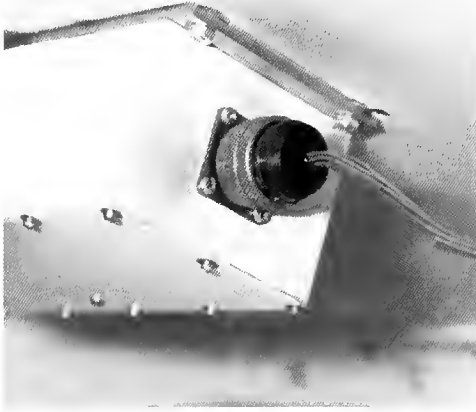
Figure 588 (Postflight). This close-up photograph is of the lower canister. There is a discoloration or shielding pattern around the grid voltage plug.

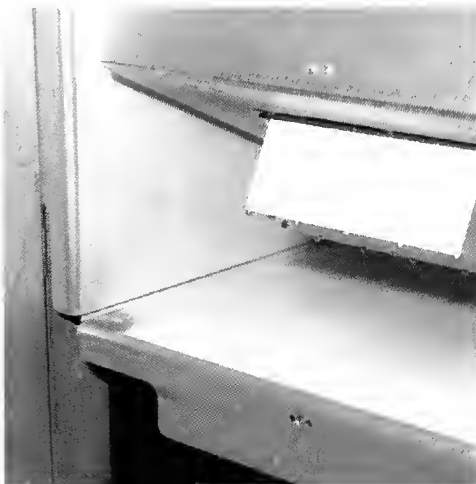
Figure 589 (Postflight). This close-up photograph is of the lower left corner of the tray. Note the brown discoloration on the left wall of the tray.

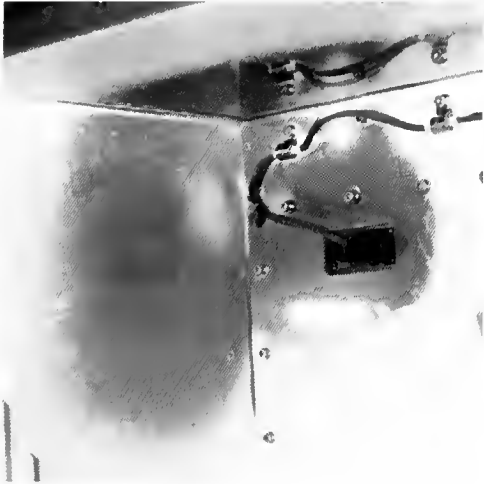
Figure 590 (Postflight). This close-up photograph is of the upper left corner of the tray. Note the extreme brown discoloration. There is a photographic light reflection just below the grid voltage plug. There is also a reflection of the electrical cable in the tray sidewall.

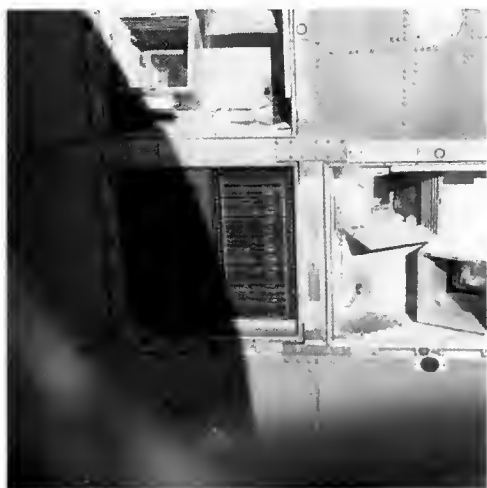
Figure 592
Photo No. S32-75-062
Dup. Neg. No.: L90-10368
LISAR NO.: EL-1994-00673
Photo Credit: JSC
Photo Date: 1/12/90
Location: In Flight
Subject: In-Flight Survey of Tray H7

Figure 592 (In Flight). A shadow cast by the orbiter covers most of the left half of the tray, which contains the active part of the experiment. The experiment appears to be without physical damage. Even in the shadow, a light tan discoloration is visible on the left and lower flanges of the experiment tray. A darker stain has discolored the originally white paint dots on the experiment tray clamp blocks. Dark brown stains on the structure of the LDEF are visible in areas adjacent to the edge of thermal end panels that were designed to facilitate venting of the interior.

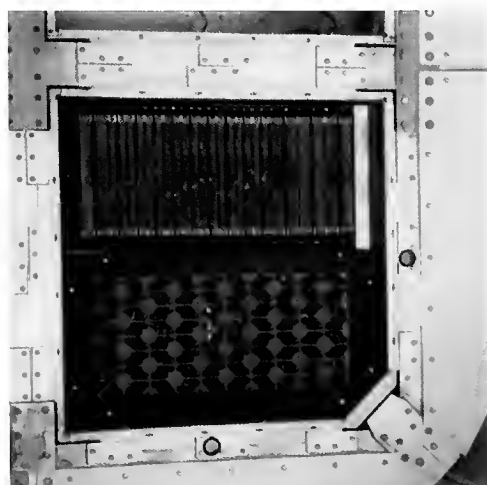
Figure 593
Photo No.: S32(S)-288
Dup. Neg. No.: L92-21195
LISAR NO.: EL-1994-00075
Photo Credit: JSC
Photo Date: 1/22/90
Location: Shuttle Cargo Bay at Dryden
Subject: Postflight Survey of Tray H7

Figure 593 (Postflight). The experiment appears to have no physical damage. This photograph was taken from the cargo bay access hatch of the orbiter during postlanding operations at the Dryden Flight Research Center. Note the discolorations on the structure of the LDEF, the tray flanges, and the tray clamp white dots and the variation of discoloration with proximity to the thermal panel vents. The black thermal coating on the passive part of the experiment appears unchanged, while the black thermal coating on the active part of the experiment appears dark gray. The surfaces of the Kapton film specimens of the passive experiment appear to have changed from specular to diffuse after exposure to the space environment.

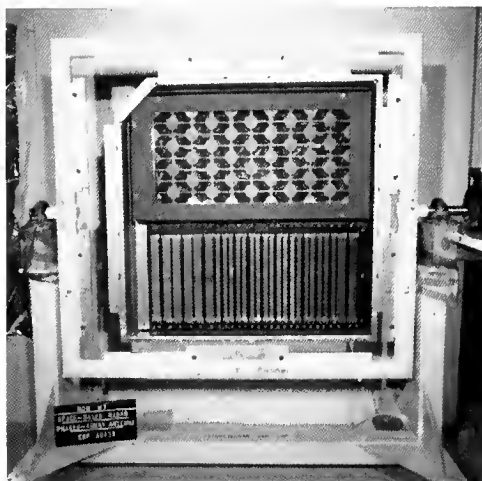
Figure 594
Photo No.: KSC-390C-1990.01
Dup. Neg. No.: L91-15659
LISAR NO.: EL-1994-00295
Photo Credit: KSC
Photo Date: 3/15/90
Location: KSC SAEF II
Subject: Postflight Survey of Tray H7

Figure 594 (Postflight). Experiment AO133 appears to have no physical damage. A light tan discoloration is visible on the left and lower flanges of the experiment tray and also on the unpainted aluminum filler to the left of the passive part of the experiment. A darker stain has discolored the lower corners of the tray structure. The black thermal coating on the active part of the experiment has changed from flat black to dark gray. The coating on the passive part of the experiment appears less degraded. The exposed surfaces of the Kapton film specimens in both the active and passive parts of the experiment appear to have changed from specular to diffuse because of exposure to the space environment.

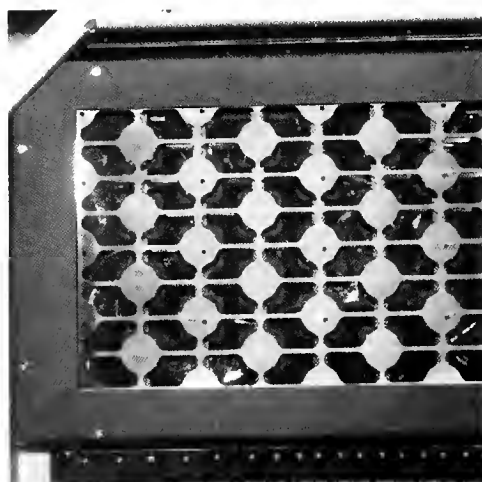
Figure 595
Photo No.: KSC-390C-1990.03
Dup. Neg. No.: L91-15642
LISAR NO.: EL-1994-00409
Photo Credit: KSC
Photo Date: 3/15/90
Location: KSC SAEF II
Subject: Postflight Detail of Upper Left of Tray H7

Figure 595 (Postflight). This photograph is of the upper left one-fourth of the tray. The experiment is intact, but the surface appears lighter than in preflight conditions. Light reflections from some underlying surfaces are visible.

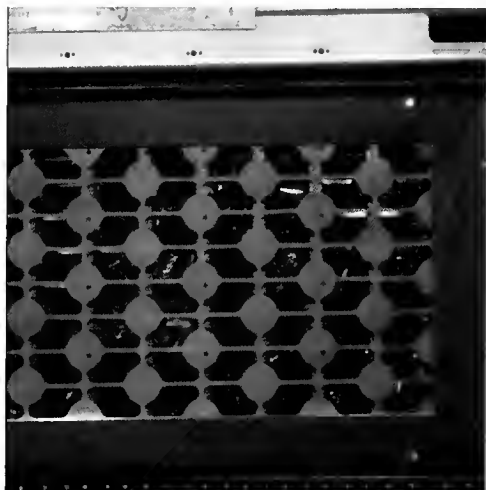
Figure 596 (Postflight). This photograph is of the upper right one-fourth of the tray. The experiment is intact, but the surface appears lighter than in preflight conditions. Light reflections from some underlying surfaces are visible.

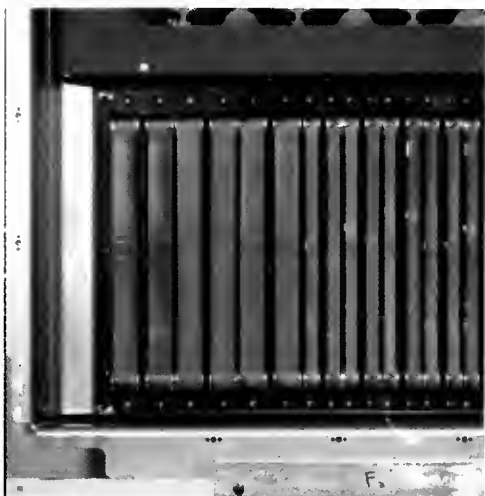
Figure 597 (Postflight). This photograph is of the lower left one-fourth of the tray. The experiment is intact. The color of the test specimens does not appear as dark as in preflight.

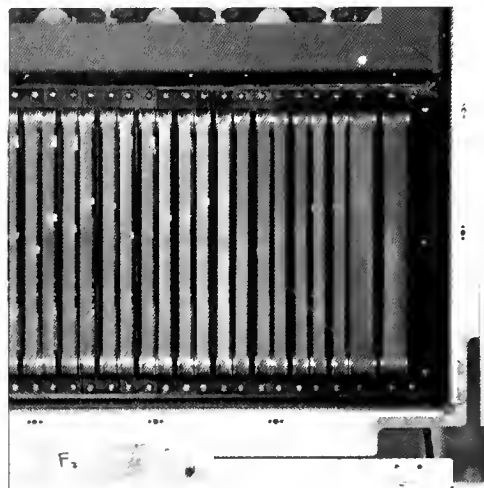
Figure 598 (Postflight). This photograph is of the lower right one-fourth of the tray. The experiment is intact, but the test specimens are not as dark as in preflight. Light reflections from some underlying surfaces are visible.

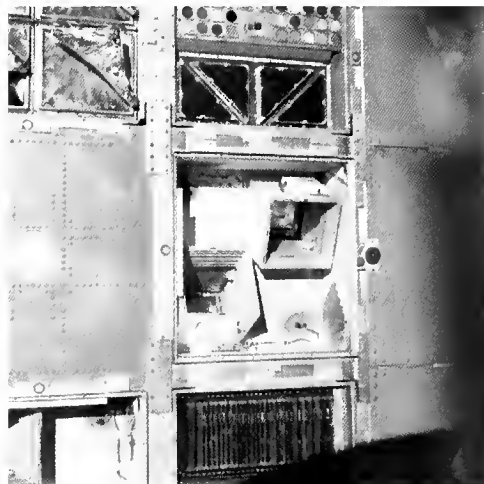
Figure 600
Photo No.: S32-75-061
Dup. Neg. No.: L90-10367
LISAR NO.: EL-1994-00672
Photo Credit: JSC
Photo Date: 1/12/90
Location: In Flight
Subject: In-Flight View of Tray H9

Figure 600 (In Flight). A very light contamination stain is present on the experiment tray flanges and on most of the visible structure of the LDEF. The exception is a darker stain on the structure adjacent to thermal panels that provided venting for the interior. Both paint dots are heavily coated with the brown contamination stain. The color of the white thermal control paint now varies from off-white to dark brown with areas of concentrated brown discoloration. A beryllium copper collector foil is clearly visible in the lower left canister housing as are the baffles. Reflected light from the fine wire mesh grid is visible near the top of the canister housing. Because of an experiment system malfunction, the canister collector foils that are visible were exposed for the total mission.

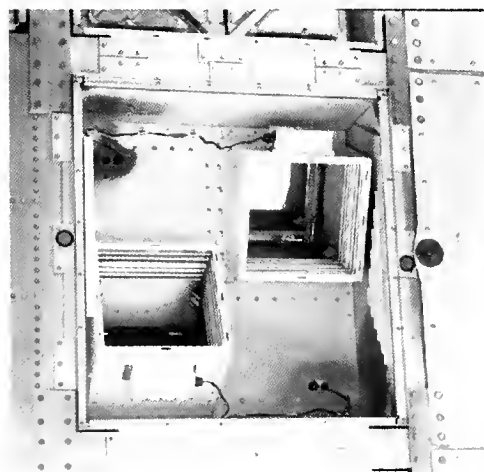
Figure 601
Photo No.: S32(S)-286
Dup. Neg. No.: L92-21193
LISAR NO.: EL-1994-00074
Photo Credit: JSC
Photo Date: 1/22/90
Location: Shuttle Cargo Bay at Dryden
Subject: Postflight Survey of Tray H9

Figure 601 (Postflight). This photograph was taken from the cargo bay access hatch of the orbiter during postlanding operations at the Dryden Flight Research Center. Note the discolorations on the structure of the LDEF, tray flanges, and tray clamp white dots and the variation of discoloration with proximity to the thermal panel vents. The color of the white thermal control paint now varies from off-white to dark brown with areas of concentrated discoloration. A beryllium copper collector foil is clearly visible in the upper right canister housing as are the baffles. Reflected light from the fine wire mesh grid is visible near the top of the canister housing.

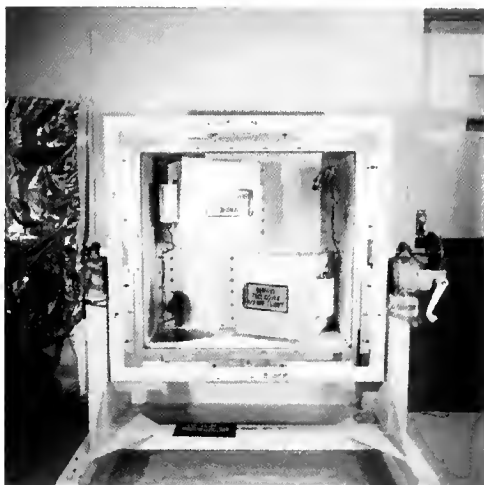
Figure 602
Photo No.: KSC-390C-1636.10
Dup. Neg. No.: L91-11881
LISAR NO.: EL-1994-00214
Photo Credit: KSC
Photo Date: 3/6/90
Location: KSC SAEF II
Subject: Postflight Survey of Tray H9

Figure 602 (Postflight). The brown stains are still very prominent and appear to be the same as in the in-flight photograph. The openings in the baseplate for the grid voltage cable connector mounts are thought to be the source of the darker brown stains around the connectors. The covers were installed on the canister housings to protect the space-exposed hardware. The contamination stain provides an outline of tray clamp block locations on the tray flanges.

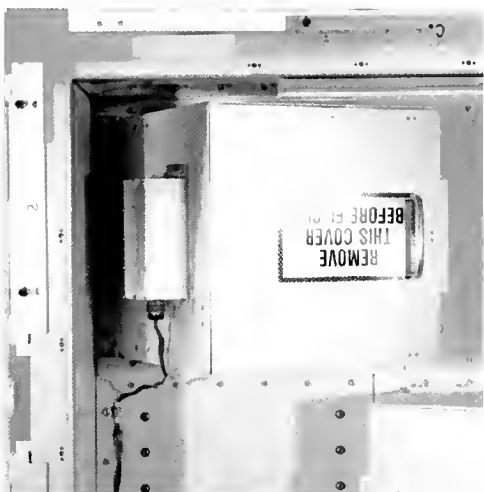
Figure 603
Photo No.: KSC-390C-1637.01
Dup. Neg. No.: L91-11912
LISAR NO.: EL-1994-00656
Photo Credit: KSC
Photo Date: 3/6/90
Location: KSC SAEF II
Subject: Postflight Detail of Upper Left of Tray H9

Figure 603 (Postflight). This photograph is of the upper left one-fourth of the tray. Note the discoloration on the tray around the canister. The cover was installed on the canister housing to protect the space-exposed hardware.

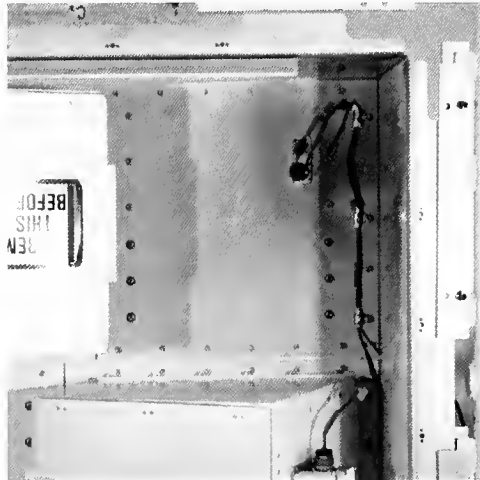
Figure 604
Photo No.: KSC-390C-1637.02
Dup. Neg. No.: L91-11913
LISAR NO.: EL-1994-00695
Photo Credit: KSC
Photo Date: 3/6/90
Location: KSC SAEF II
Subject: Postflight Detail of Upper Right of Tray H9

Figure 604 (Postflight). This photograph is of the upper right one-fourth of the tray. Note the dark brown discoloration on the tray around the canister. A shadow of the canister is caused by the photographic lights. The cover was installed on the canister housing to protect the space-exposed hardware.

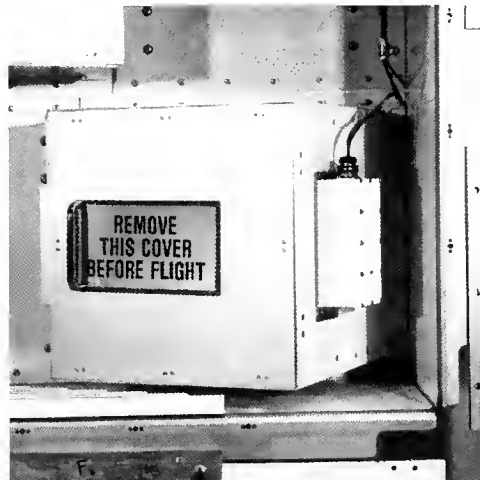
Figure 605
Photo No.: KSC-390C-1637.03
Dup. Neg. No.: L91-11914
LISAR NO.: EL-1994-00696
Photo Credit: KSC
Photo Date: 3/6/90
Location: KSC SAEF II
Subject: Postflight Detail of Lower Right of Tray H9

Figure 605 (Postflight). This photograph is of the lower right one-fourth of the tray. Note the discoloration on the tray around the canister. Some photographic light shadows are present. The cover was installed on the canister housing to protect the space-exposed hardware.

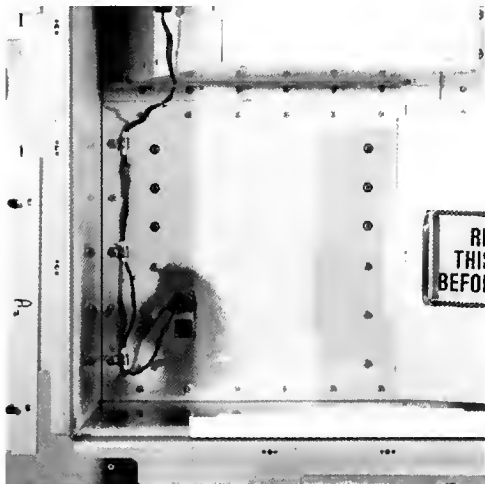
Figure 606 (Postflight). This photograph is of the lower left one-fourth of the tray. Note the extreme brown discoloration on the tray around the grid voltage lead and plug. There are reflections of the lead in the bottom of the tray. The cover was installed on the canister housing to protect the space-exposed hardware.

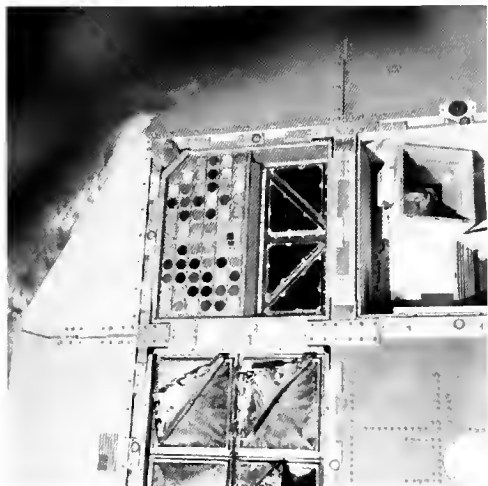
Figure 608
Photo No.: S32-75-060
Dup. Neg. No.: L90-10366
LISAR NO.: EL-1994-00671
Photo Credit: JSC
Photo Date: 1/12/90
Location: In Flight
Subject: In-Flight Survey of Tray H11

Figure 608 (In Flight). There is a brown stain on the tray structure and most aluminum surfaces of experiments. Note the discolorations on the structure of the LDEF, tray flanges, and tray clamp white dots and the variation of discoloration with proximity to the thermal panel vents. The colors in the mirrorlike surface of the detectors are a reflection of the sky and clouds. The dark spot on the detector in the third row from the top seems to be a flaw in the photograph since no damage was found in a postflight inspection.
